NONDESTRUCTIVE EVALUATIONS OF COM-  
POSITE HEATSHIELD MATERIALS BEFORE  
AND AFTER AN UNDERGROUND NUCLEAR  
EXPOSURE

Southern Research Institute

Air Force Weapons Laboratory

AFWL-TR-73-247

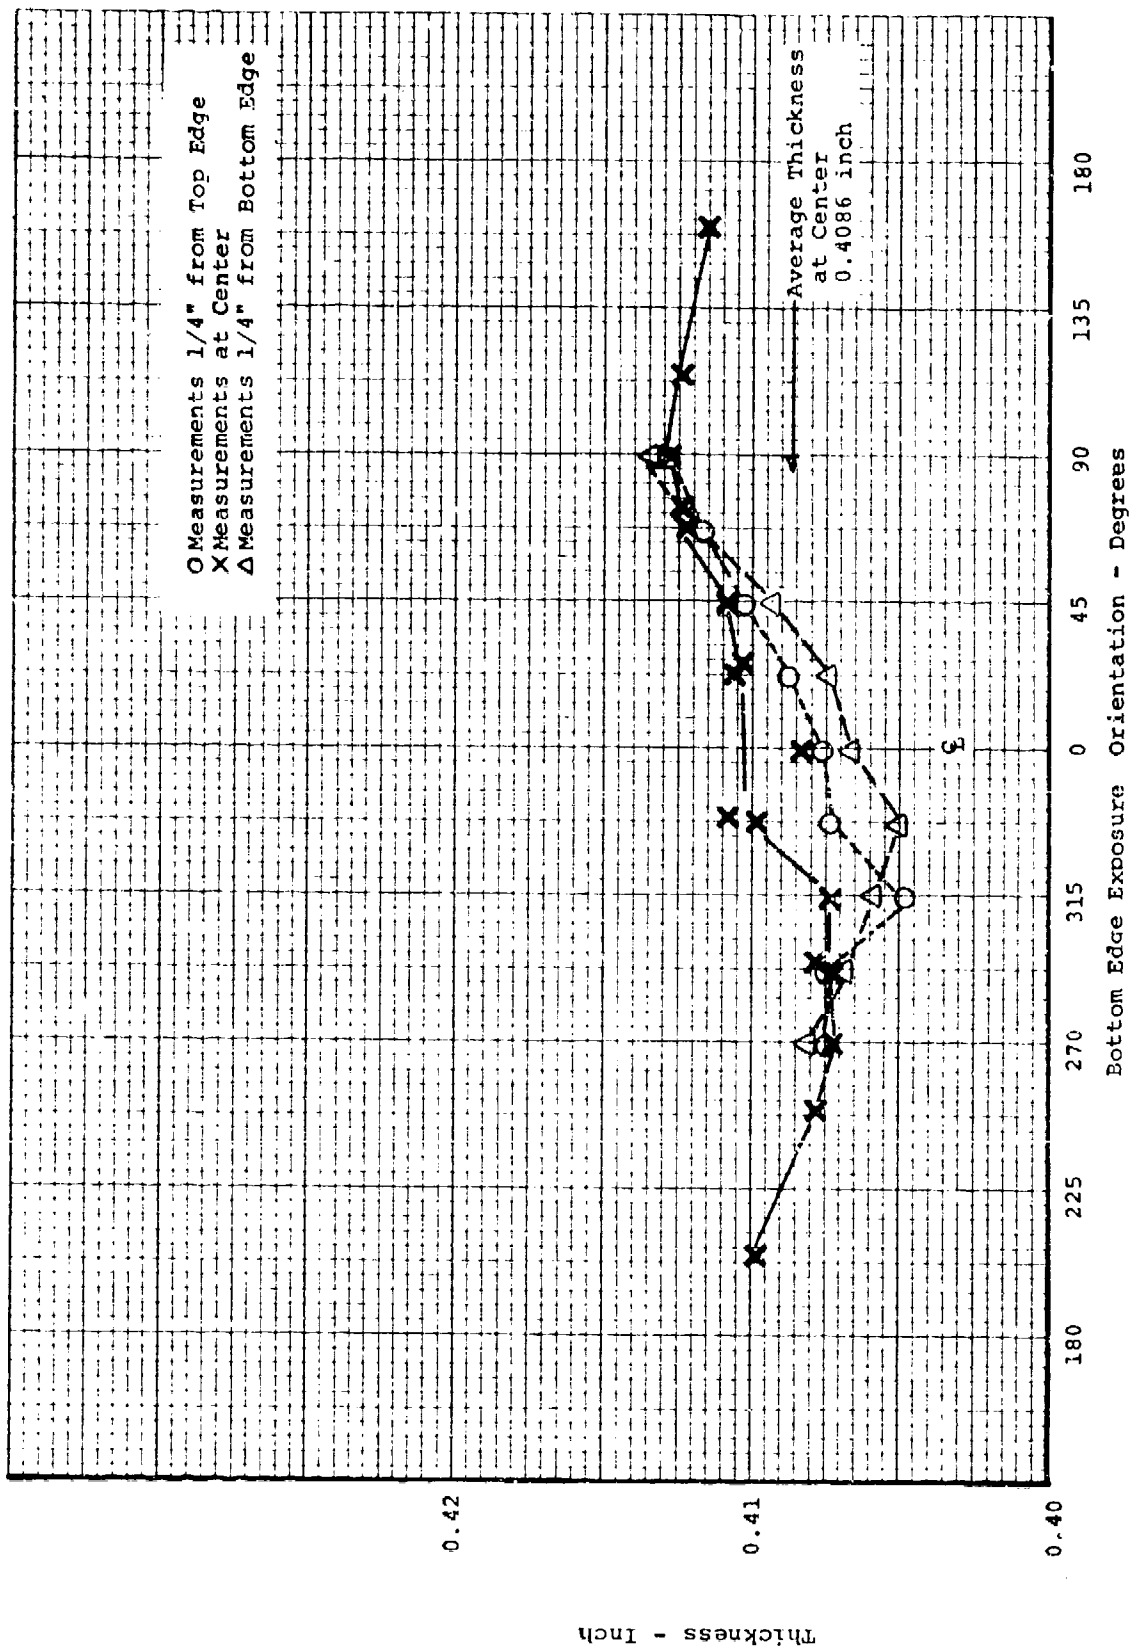
Figure 10. Thickness Variation for Ring 83301-305-1 from AVCO R6300

The following results were obtained for before and after-exposure values of density, axial velocity, radial velocity, and radial transmission. For Ring 83301-305-1, the respective values were 1.338 and 1.343 gm/cm<sup>3</sup>, 0.129 and 0.130 in./μsec, 0.127 and 0.114 in./μsec, and 44 and 43 added-dB. Significant variations in radial velocity and transmission were measured in the exposed ring. For radial velocity, low values of 0.0887, 0.0996, and 0.1011 in./μsec were measured at 0°, 45°, and 315°. For transmission, low values of 34 and 35 added-dB were measured at exposure 0°. A slight variation in thickness was measured for the exposed ring. As shown in Figure 10, thickness varied from 0.4048-inch at 315° to 0.4132-inch at 90°. For Ring 83301-305-4, the respective values were 1.339 and 1.341 gm/cm<sup>3</sup>, 0.128 and 0.130 in./μsec, 0.124 and 0.124 in./μsec, and 49 and 48 added-dB. There were no significant local variations in the data for the exposed ring, including thickness variations around the ring. For Ring 83301-400, the respective values were 1.340 and 1.343 gm/cm<sup>3</sup>, 0.128 and 0.130 in./μsec, 0.124 and 0.123 in./μsec, and 48 and 47 added-dB. There were no significant local variations in the after-exposure data, and no significant thickness variation around the ring.

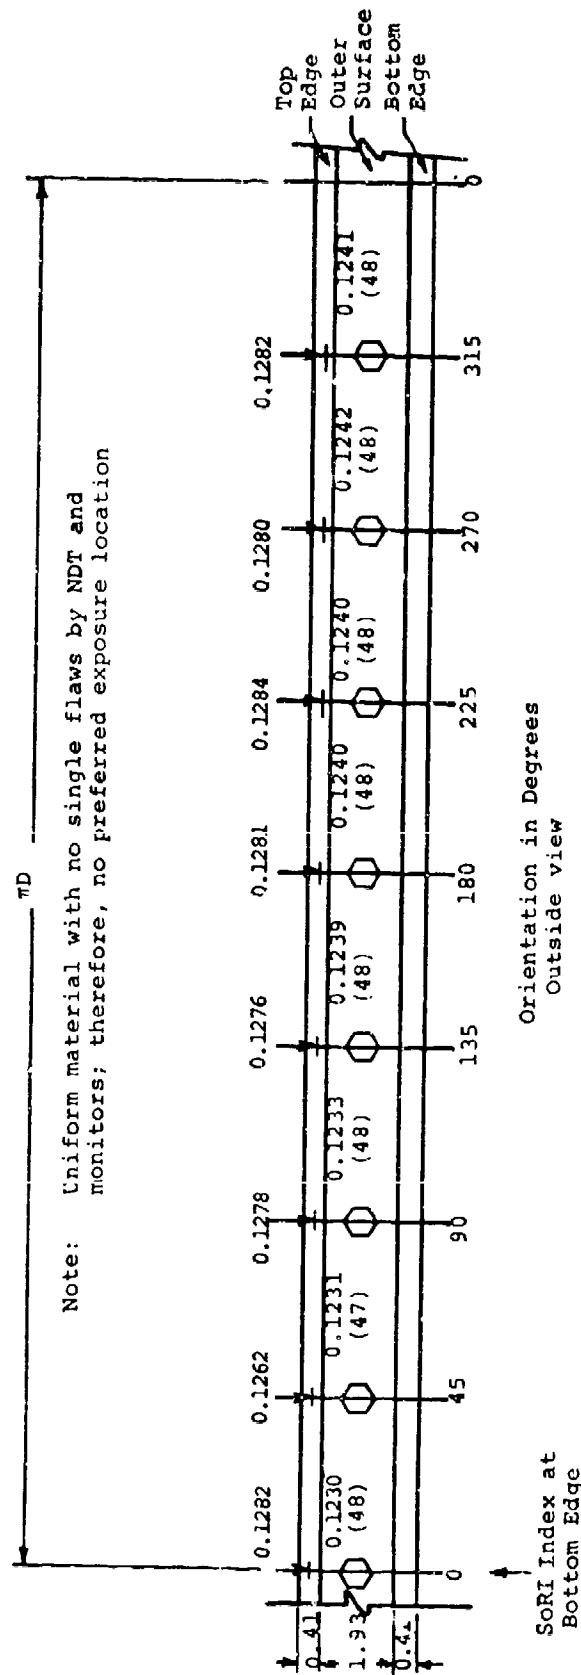
Figure 11. Sketch Showing Inspection Results on Ring 83301-400 from AVCO R6300

Sketches summarizing the NDT and monitor inspection results on the virgin rings are given in Figures 11 through 13.

Radial Velocity in in./μsec  
(Relative Radial Transmission in added-dB) - Higher readings correlate lower attenuative material
2. + Axial Velocity in in./μsec
3. Visual and penetrant inspection revealed no flaws
4. Radiography revealed uniform material with no single flaws
5. Density = 1.340 gm/cm<sup>3</sup>

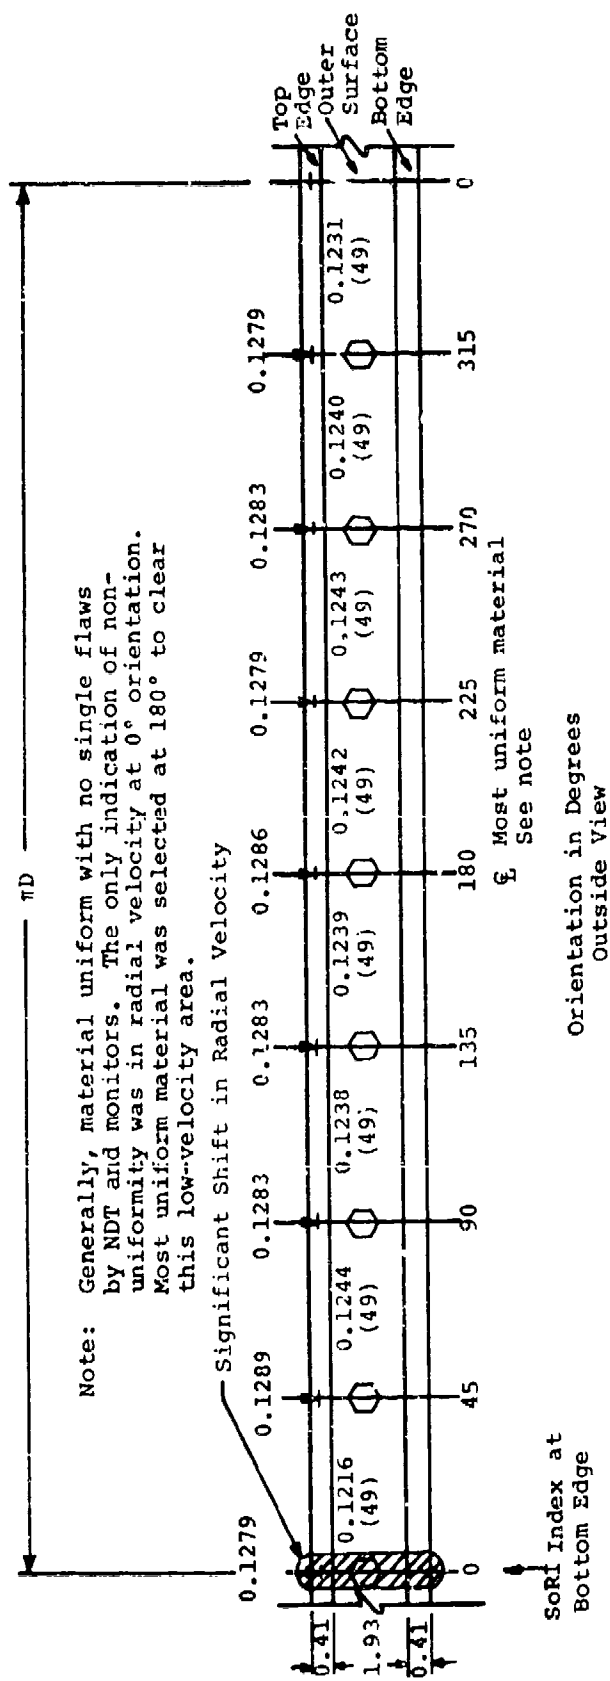
Figure 12. Sketch Showing Inspection Results on Ring 83301-305-4 from AVCO R6300

Radial Velocity in in./μsec  
(Relative Radial Transmission in added dB)-Higher readings correlate lower attenuative material
2. + Axial Velocity in in./μsec
3. Visual and penetrant inspection revealed no flaws
4. Radiography revealed uniform material with no single flaws
5. Density - 1.339 gm/cm<sup>3</sup>

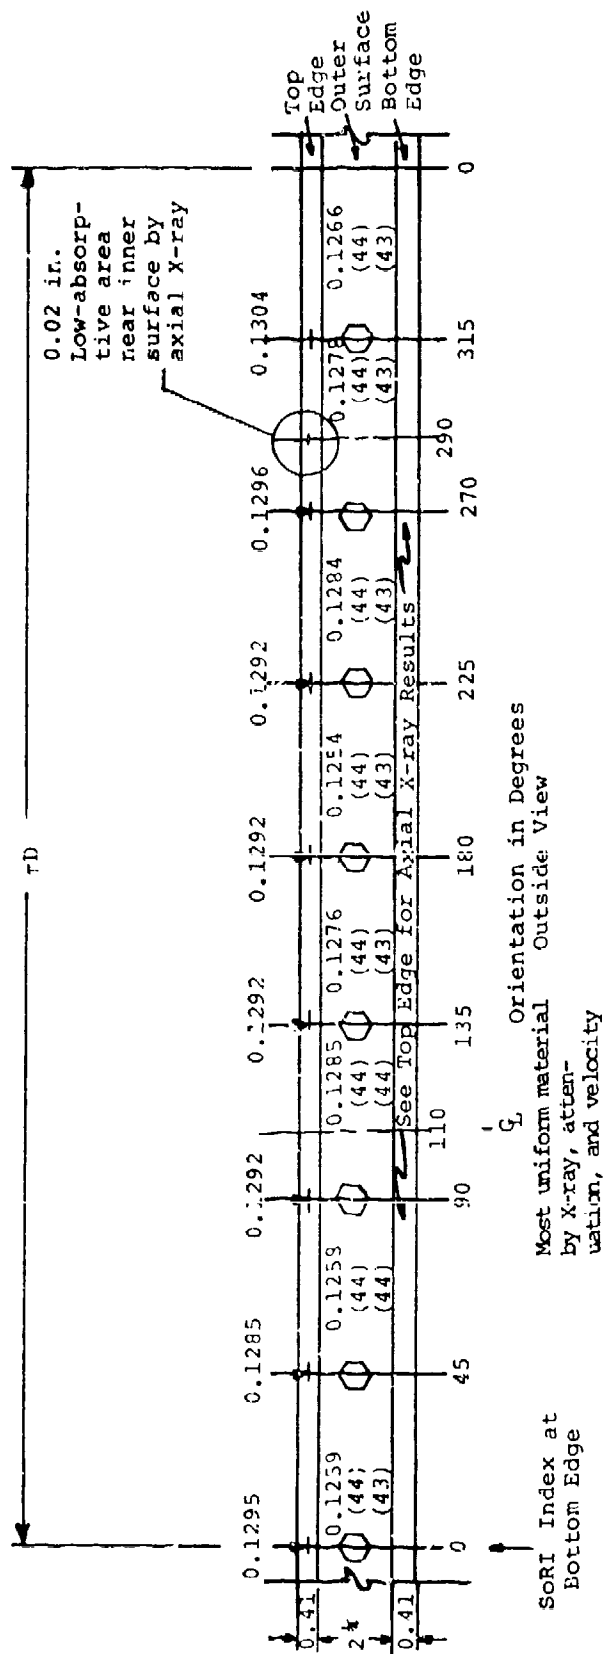
Figure 13. Sketch Showing Inspection Results on Ring 83301-305-1 from AVCO R6300

Radial velocity in in./usec  
(Relative radial transmission in added dB) - First Run { Higher attenuation readings correlate  
(Relative radial transmission in added dB) - Second Run { lower attenuative material
2.  $\downarrow$  Axial velocity in in./usec
3. Visual inspection results - no single flaws
4. Penetrant inspection on edges using 2, 2, 4 - Trimethylpentane - no single flaws

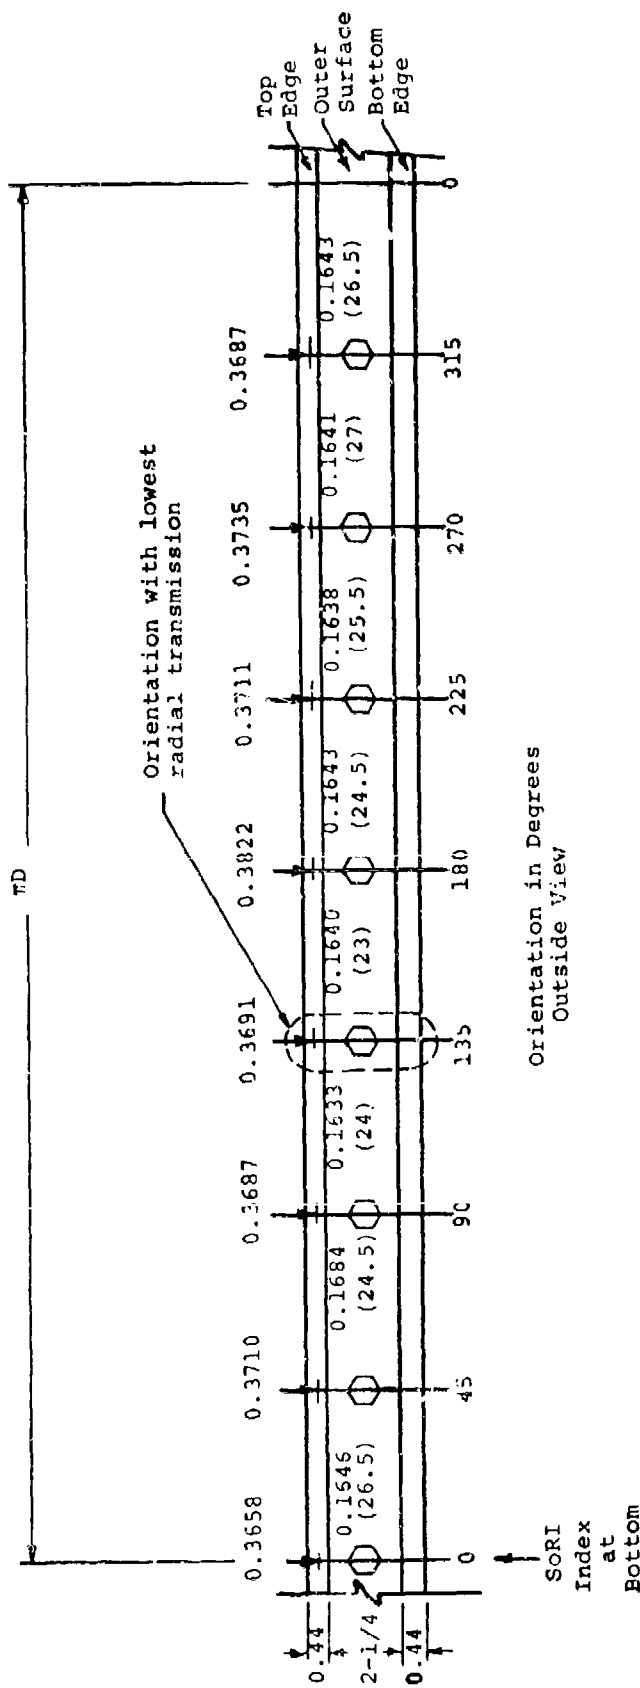
Figure 20. Sketch Showing Inspection Results on Ring 1 from AVCO 3DCP

1. ○ Radial Velocity in in./μsec  
(Average for two runs--relative radial transmission in added-dB)--Higher readings correlate lower material attenuation)
2. + Axial velocity in in./μsec
3. Visual and penetrant (2, 2, 4-Trimethylpentane) revealed no single flaws
4. Radiography was n<sup>o</sup> revealing of any single flaws
5. Density = 1.406 gm/cm<sup>3</sup>
6. Most uniform material q<sub>u</sub> - Any orientation--note lowest radial transmission orientation

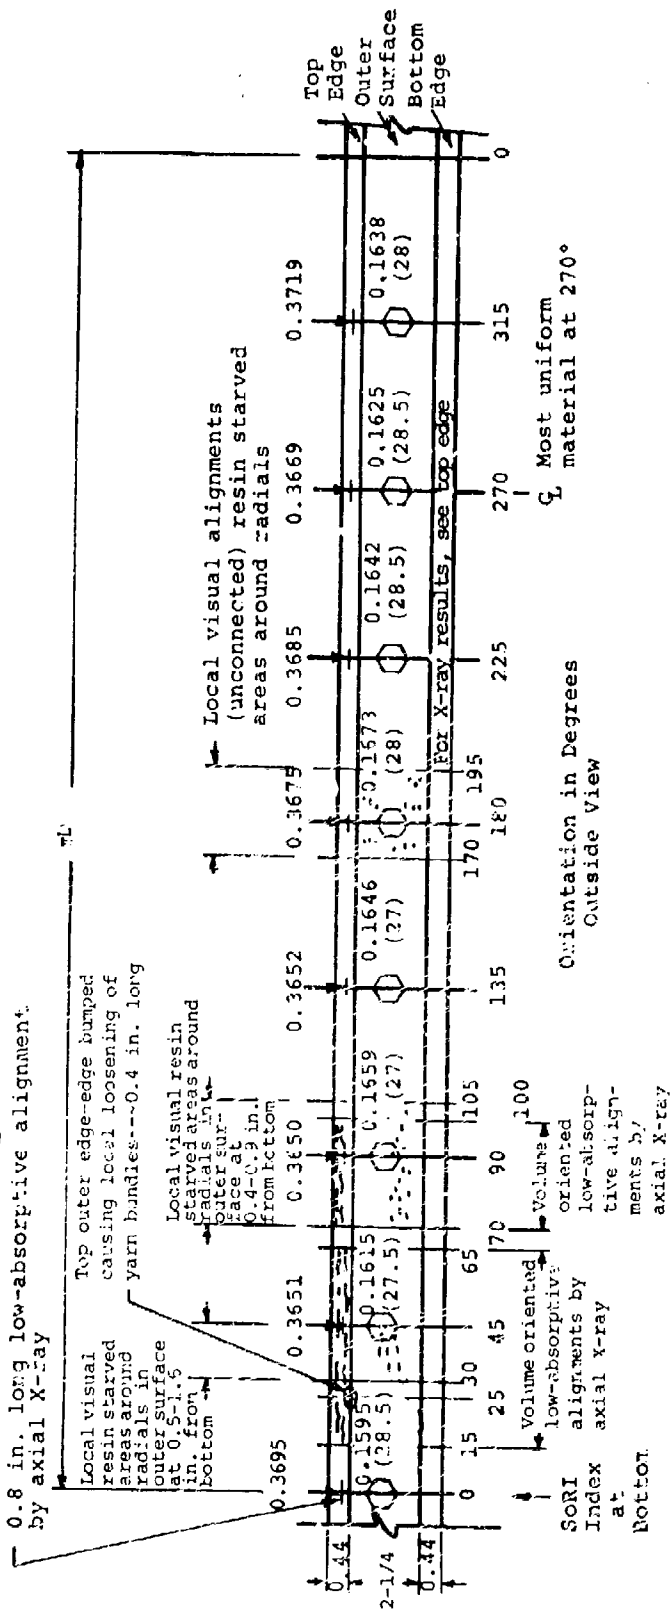
Figure 21. Sketch showing inspection Results of Ring 2 from AVCO 3DCP

Radial Velocity in in./ $\mu$ sec  
(Average for two runs-Relative Radial transmission in added-dB)-Higher readings correlate lower material attenuation.
2. + Axial Velocity in in./ $\mu$ sec
3. Penetrant (2,2,4-Trimethylpentane) not revealing
4. Density = 1.415 gm/cm<sup>3</sup>
5. Most uniform material  $Q_0$  at 270°
- 0.8 in. long low-absorptive alignment  
by axial X-ray

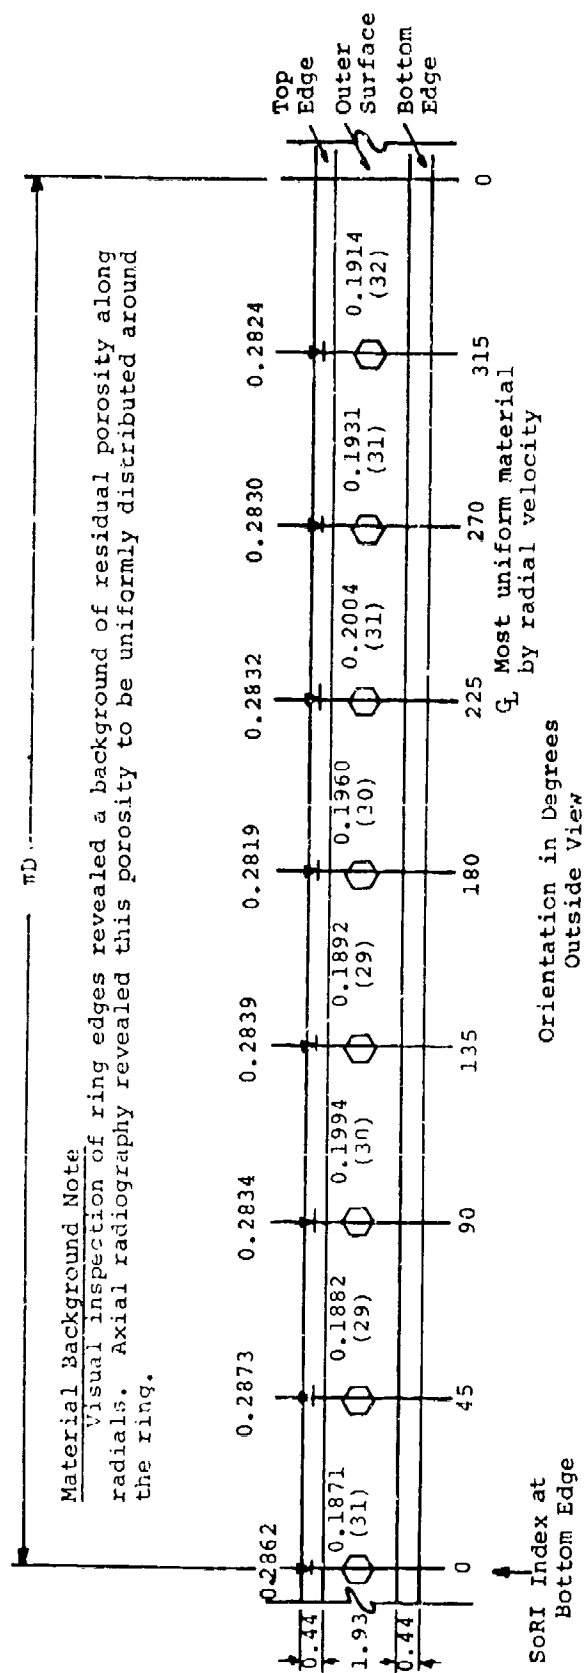
Figure 22. Sketch Showing Inspection Results on Ring 83301-200 from AVCO 3DCP

Axial Velocity in in./usec
3. Visual and penetrant inspection revealed no single flaws
4. Radiograph, revealed no single flaws
5. Density = 1.316 gm/cm<sup>3</sup> } see Background note

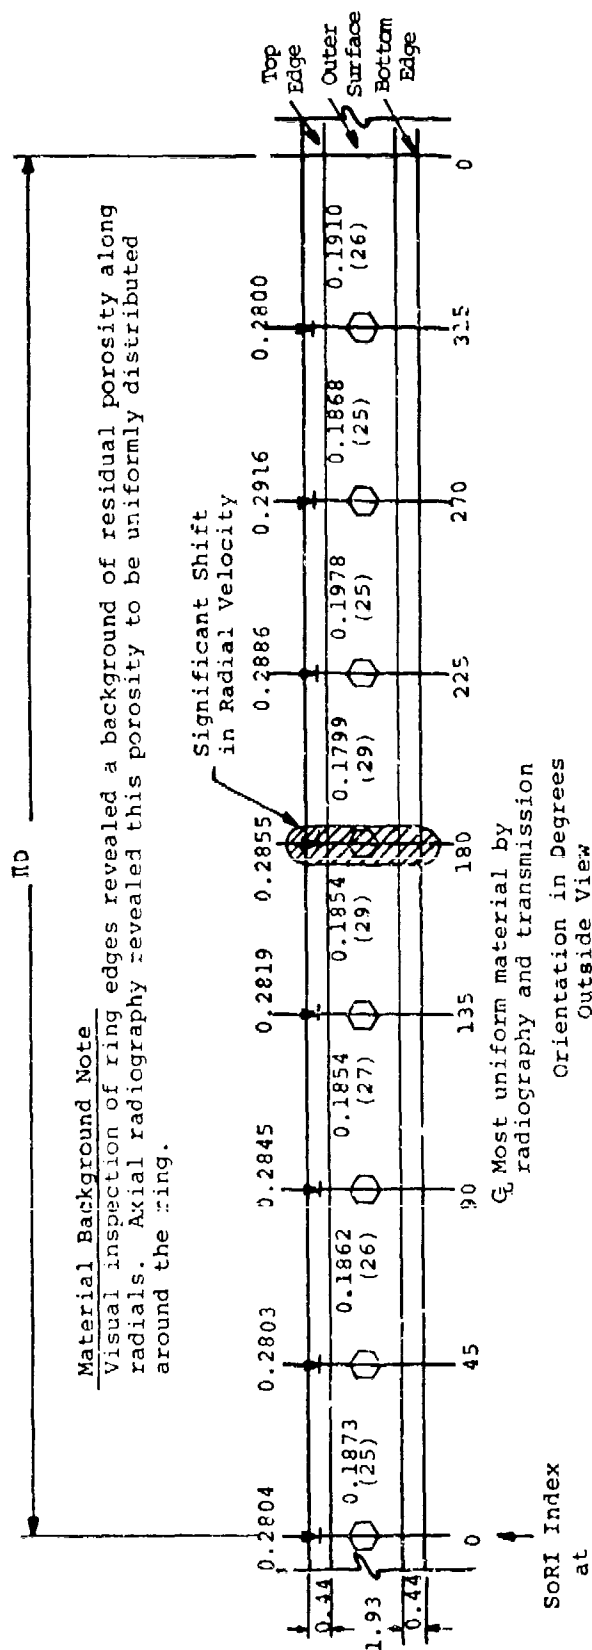
Figure 23. Sketch Showing Inspection Results on Ring 83301-202A from AVCO 3DCP

Radial Velocity in in./usec  
(Average relative radial transmission in added-dB)-Higher readings correlate lower material attenuation
2. + Axial Velocity in in./usec
3. Visual and Penetrant inspection revealed no single flaws
4. Radiography revealed no single flaws-most uniform material at 225° (first choice) and 90° (second choice)
5. Density = 1.317 gm/cm<sup>3</sup>

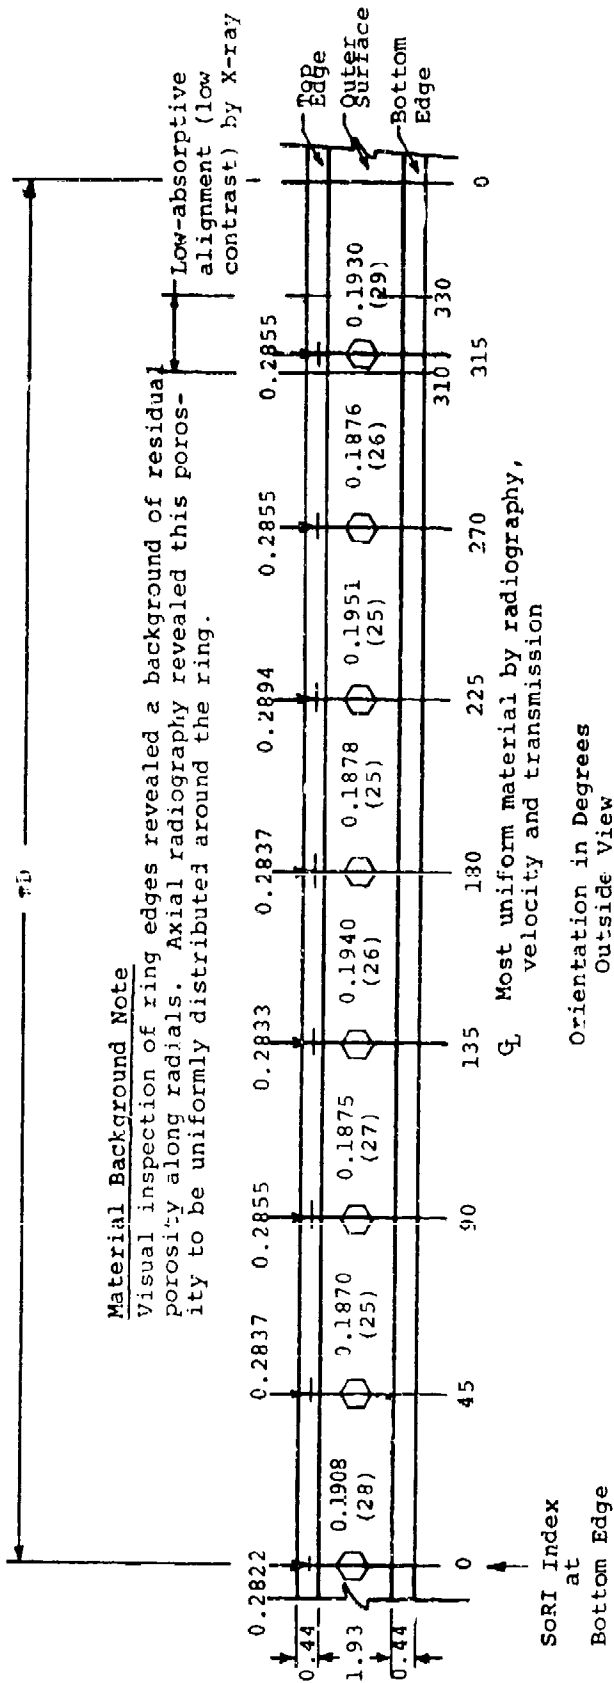
Figure 24. Sketch Showing Inspection Results on Ring 83301-305-2 from AVCO 3DCP

Radial Velocity in in./ $\mu$ sec  
(Average relative radial transmission in added-dB) - Higher readings correlate lower material attenuation
2.  $\pm$  Axial Velocity in in./ $\mu$ sec
3. Visual and penetrant inspection revealed no single flaws
4. Density = 1.316 gm/cm<sup>3</sup>

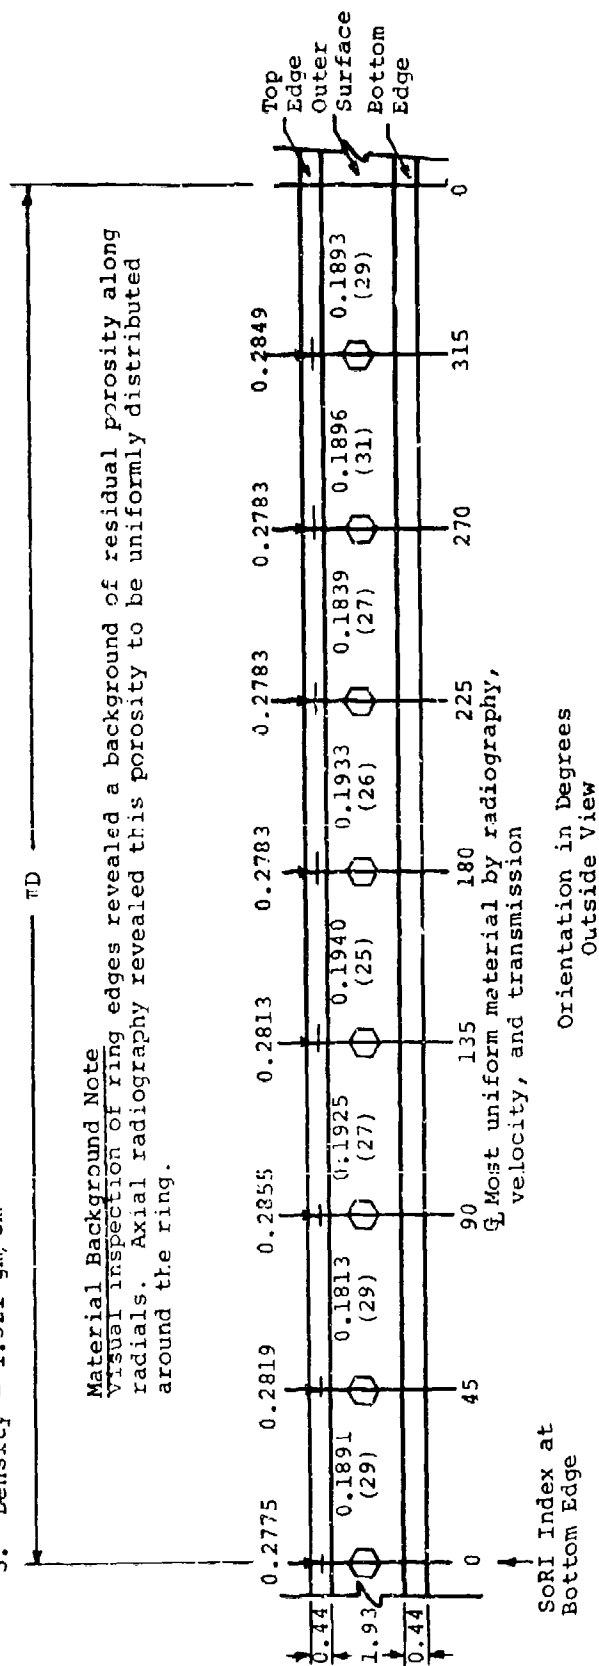
Figure 25. Sketch Showing Inspection Results on Ring 83301-305-3 from AVCO 3DCP

Radial Velocity in in./μsec  
(Average relative radial transmission in added-dB)-Higher readings correlate lower material attenuation
2. + Axial Velocity in in./μsec
3. Visual and penetrant inspection revealed no single flaws
4. Radiography revealed no single flaws - most uniform material at 90° and 180° orientation
5. Density = 1.321 gm/cm<sup>3</sup>

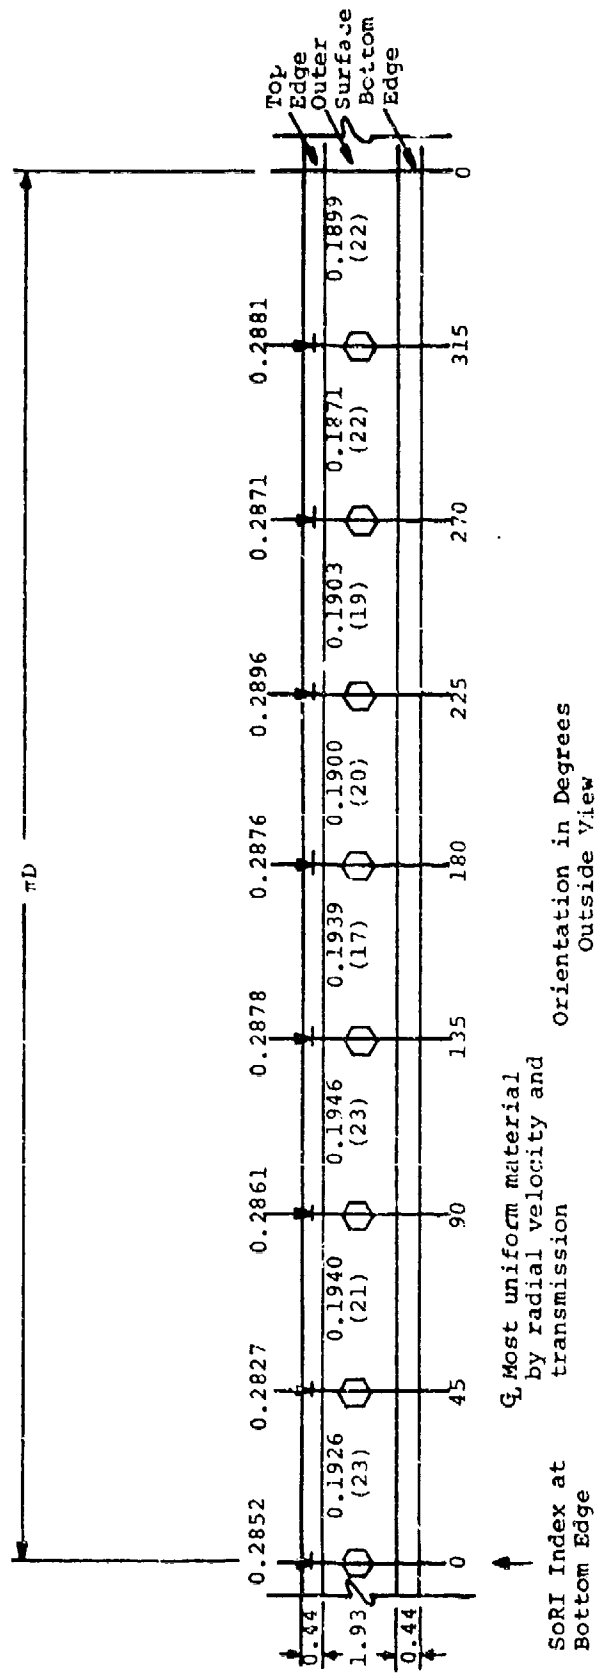
Figure 28. Sketch Showing Inspection Results on Ring 83301-202B from AVCO 3DCP/QP

No single flaws were detected in the virgin rings by vision, X-ray, and liquid penetrant. Sketches summarizing the NDT and monitor inspection results on Rings 83301-202B and 83301-305-5 are given in Figures 28 and 29.

Radial velocity in in./ $\mu$ sec  
(Relative radial transmission in added-dB)-Higher readings correlate lower material attenuation
2. + Axial velocity in in./ $\mu$ sec
3. Visual and penetrant inspection revealed no single flaws
4. Radiography revealed uniform material with no single flaws
5. Density = 1.343 gm/cm<sup>3</sup>

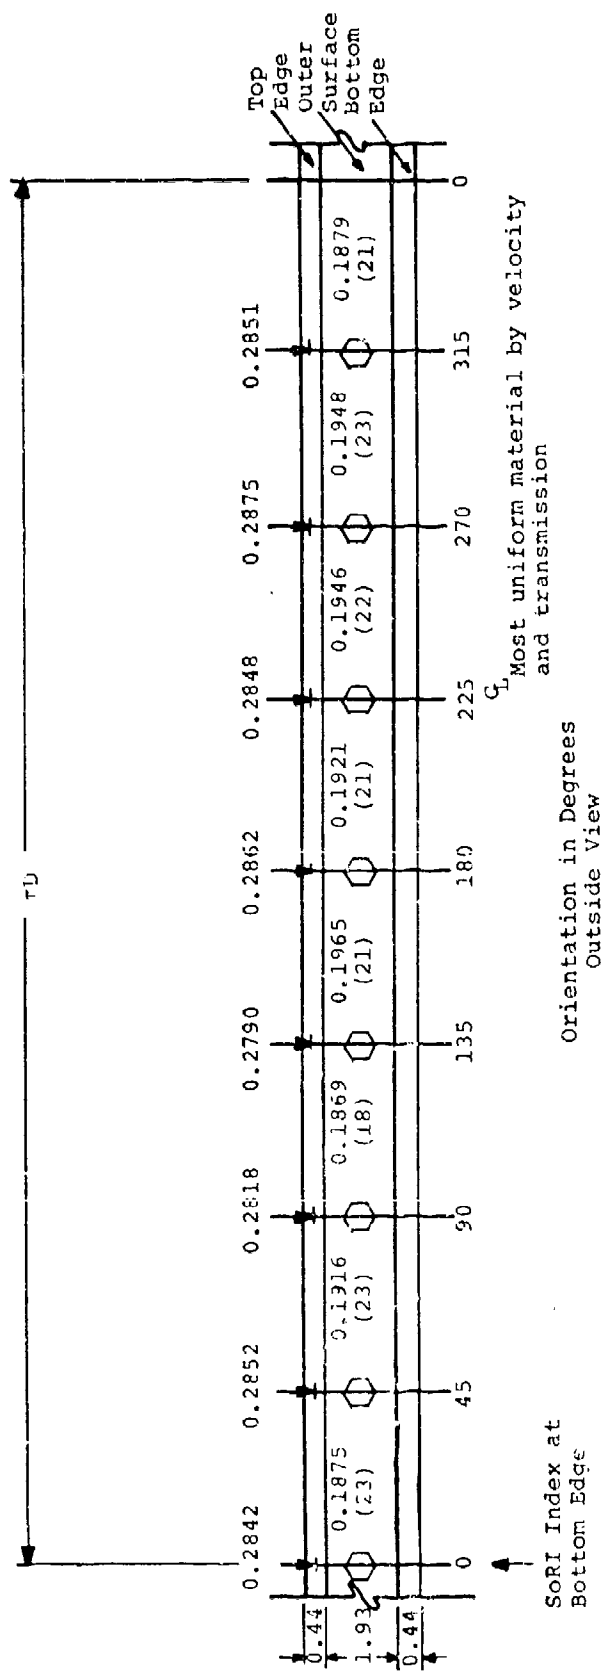
Figure 29. Sketch Showing Inspection Results on Ring 83301-305-5 from AVCO 3DCP/QP

Radial velocity in in./μsec  
(Relative radial transmission in added-dB)-Higher readings correlate lower material attenuation
2. + Axial velocity in in./μsec
3. Visual and penetrant inspection revealed no single flaws
4. Radiography revealed uniform material with no single flaws
5. Density = 1.354 gm/cm<sup>3</sup>

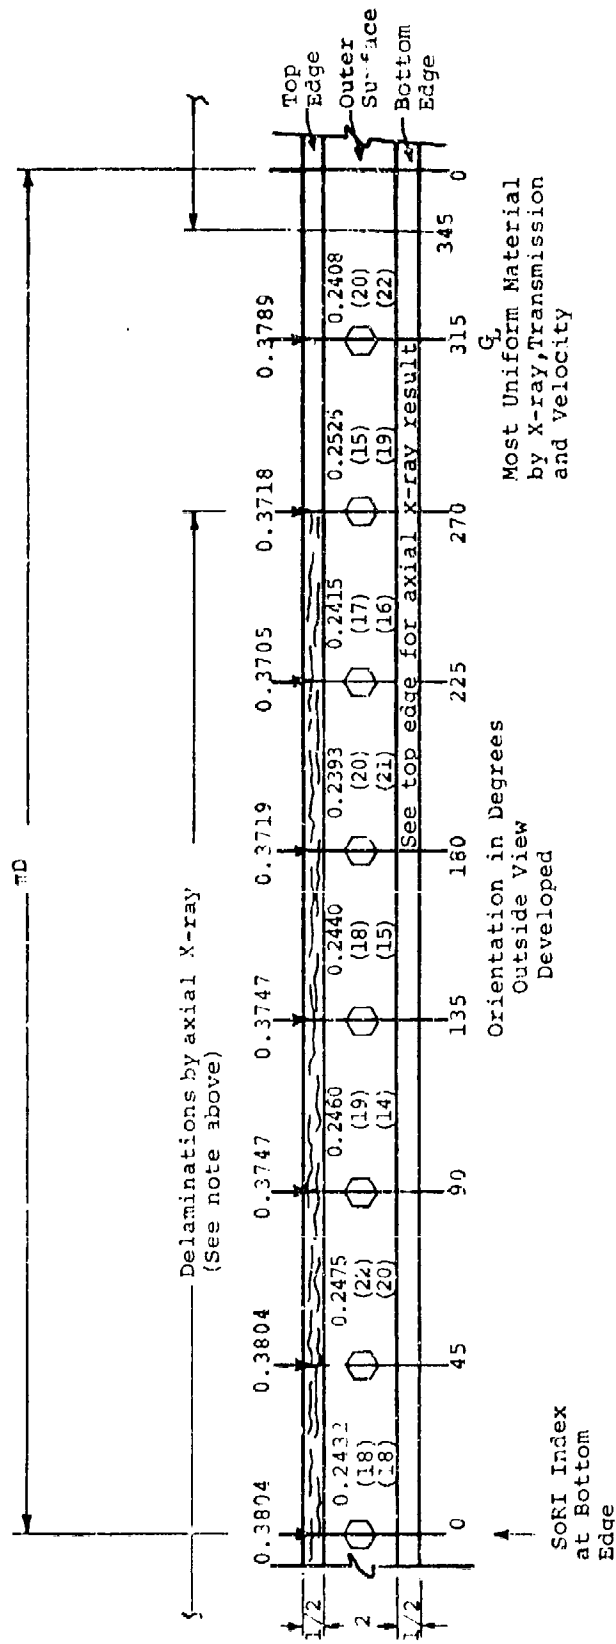
Figure 31. Sketch Showing Inspection Results on Ring 1109-35-2 from AVCO 3DCC

Radial Velocity in in./μsec  
(Radial ultrasonic transmission in added-dB)-First Run } Higher transmission readings correlate  
(Radial ultrasonic transmission in added-dB)-Second Run } lower attenuative material
2.  $\uparrow$  Axial Velocity in in./μsec
3. Visual inspection results - no single flaws
4. Penetrant inspection on edges using 2,2,4 Trimethylpentane-no single flaws.
5. This material had a visual background delaminations extending across radials in the axial and circumferential directions. Occurrence was frequent
6. Bulk density = 1.638 gm/cm<sup>3</sup>

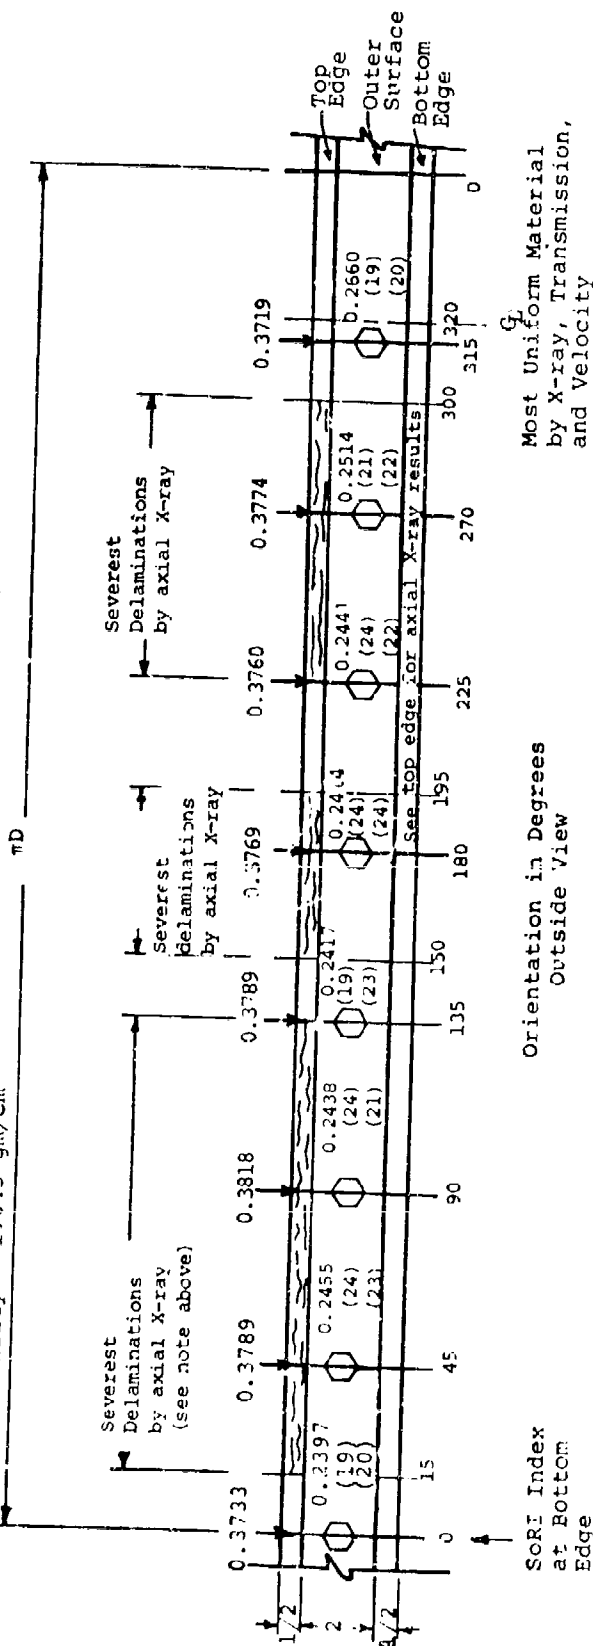
Figure 32. Sketch Showing Inspection Results on Ring 1109-35-3 from AVCO 3DCC

Radial velocity in in./usec  
(Radial Ultrasonic transmission in added-dB)-First Run } Higher transmission readings correlate  
(Radial Ultrasonic transmission in added-dB)-Second Run } lower attenuative material.
2. + Axial velocity in in./usec
3. Visual inspection results-no single flaws
4. Penetrant inspection on edges using 2,2,4 Trimethylpentane-no single flaws
5. This material had a high frequency of background circumferential delaminations extending across radials in the axial and circumferential directions by vision.
6. Bulk density = 1.645 gm/cm<sup>3</sup>

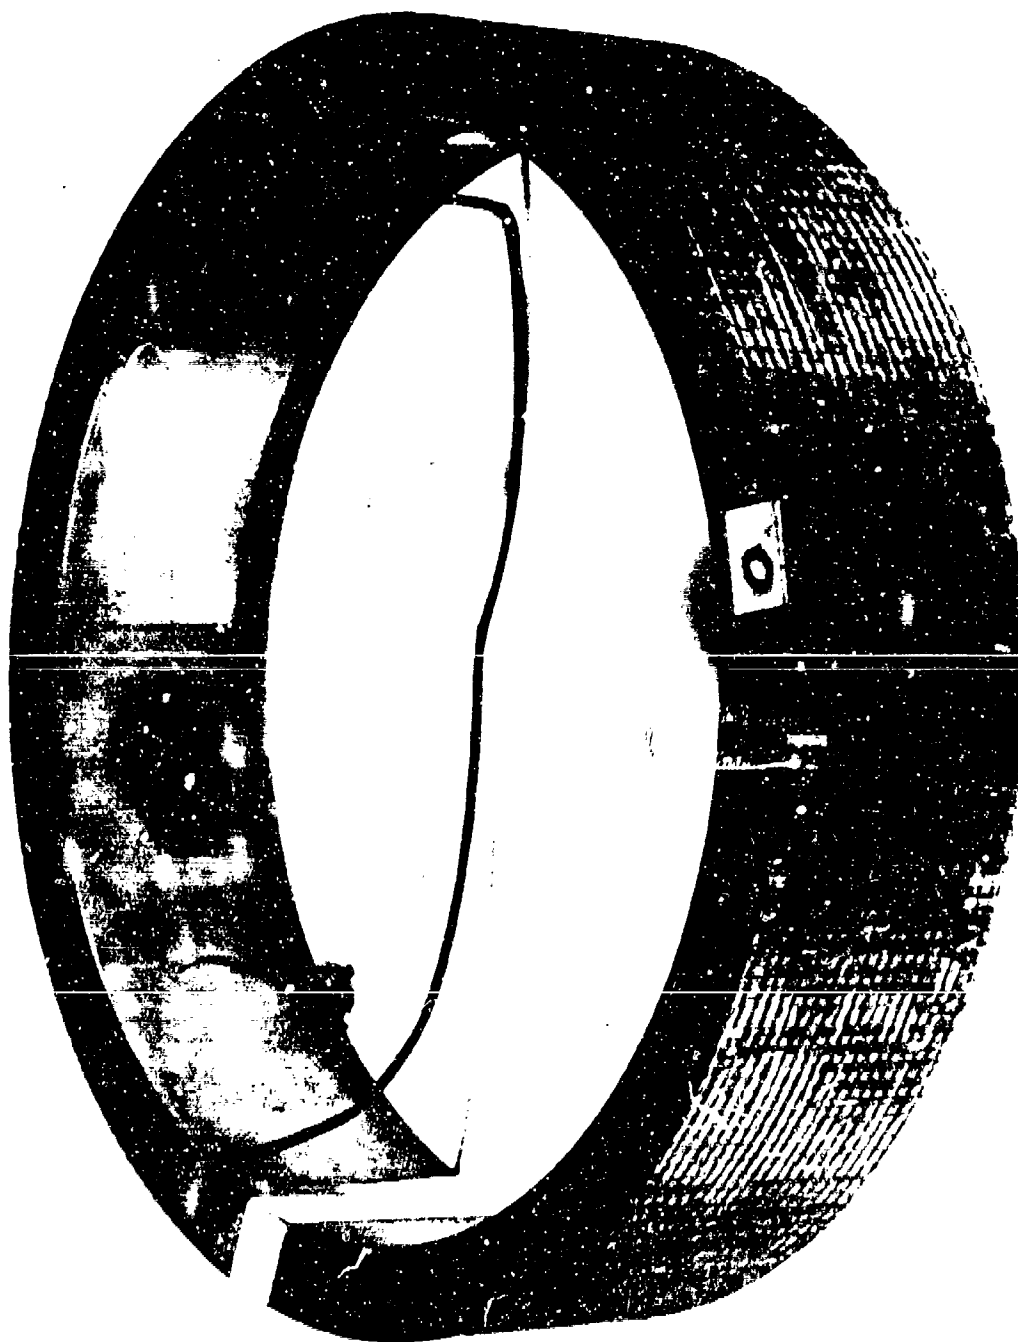
Figure 34. Photographs Showing As-Received Ring 1109-35-3 from  
AVCO 3DCC After Exposure

Structural change was visually apparent in both rings. Photographs showing the as-received rings are given in Figures 33 and 34. Generally, for both rings, the change consisted of raised or recessed and missing radials, cracking along local preexisting circumferential delams completely around the ring,

spalled sections of matrix and circumferential reinforcement (circo) over radials in edges, yarn lift from the front face, and discolorations (dark) on the front face. These and other changes are detailed in Table 5 and Figures 35 and 36. Absorption of trimethylpentane into edges of both exposed rings was higher in the exposed zone than out of the exposed zone. The only change indicated by axial X-ray was a 1-1/2-inch long circumferential low-absorptive alignment at 315°.

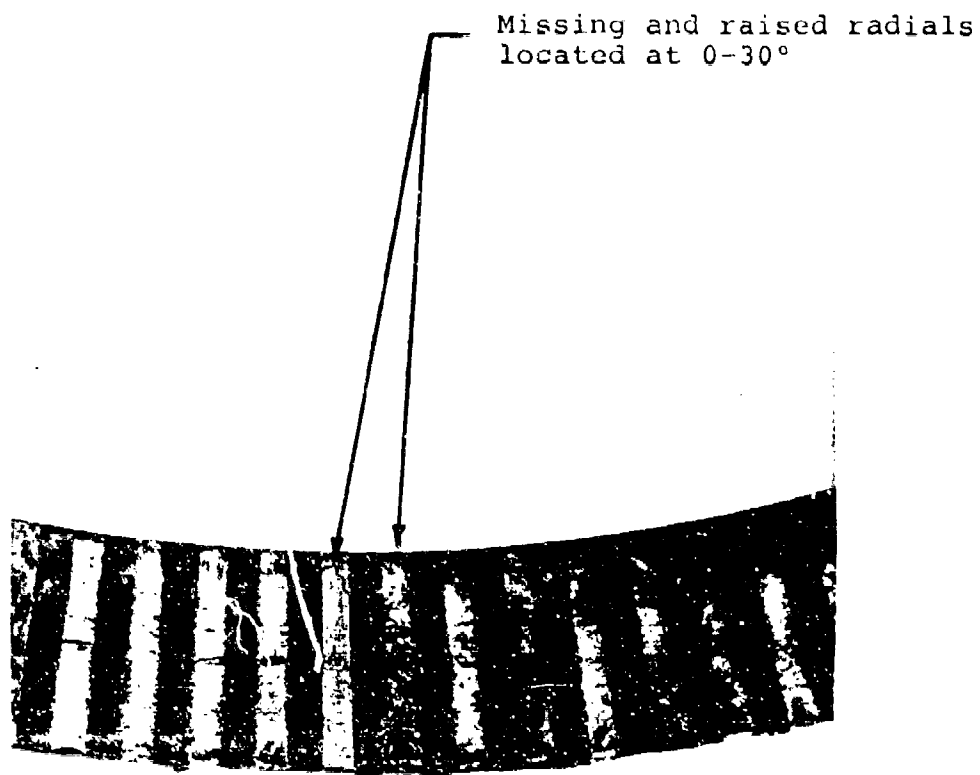
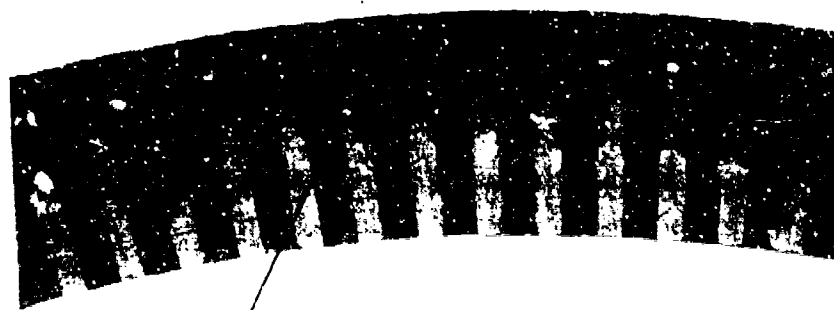
Figure 36. Photographs Showing Structural  
Change After Exposure in Ring  
1109 -35-3 from AVCO 3DCC

Cracking Along Pre-existing  
Circumferential Delaminations

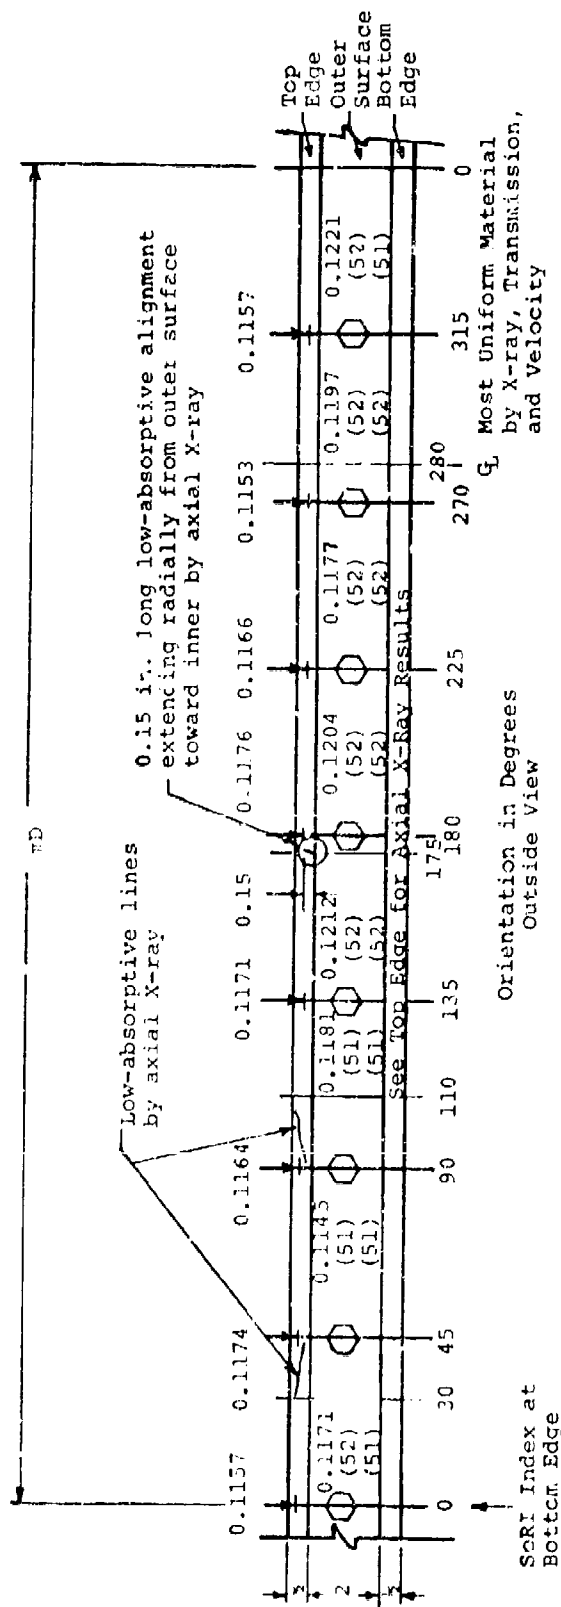
Figure 38. Sketch Showing Inspection Results on Ring 9N-2 from Sandia Felt CC

From the visual, X-ray, and liquid penetrant inspections on the before-exposure rings, only axial X-ray was effective in determining single flaws. For 9N-2, the single flaws revealed were a single skew low-absorptive alignment at 110 - 125° and a single 0.15-inch long radial low-absorptive alignment which extended inward from the outer surface at 255°. For 9P-2, the only single flaw revealed was a 1/4-inch by 1/2-inch low-absorptive area near the inner surface at 225°. Orientations were designated to avoid these flaws. Sketches summarizing the NDT and monitor results are given in Figures 38 and 39.

1.  $\odot$  Radial velocity in in./usec  
(Relative radial transmission in added-dB) - First Run } Higher transmission readings correlate  
(Relative radial transmission in added-dB) - Second Run } lower attenuative material
2.  $\downarrow$  Axial velocity in in./usec
3. Visual inspection results - no single flaws
4. Penetrant inspection on edges using 2, 2, 4-Trimethylpentane - no single flaws

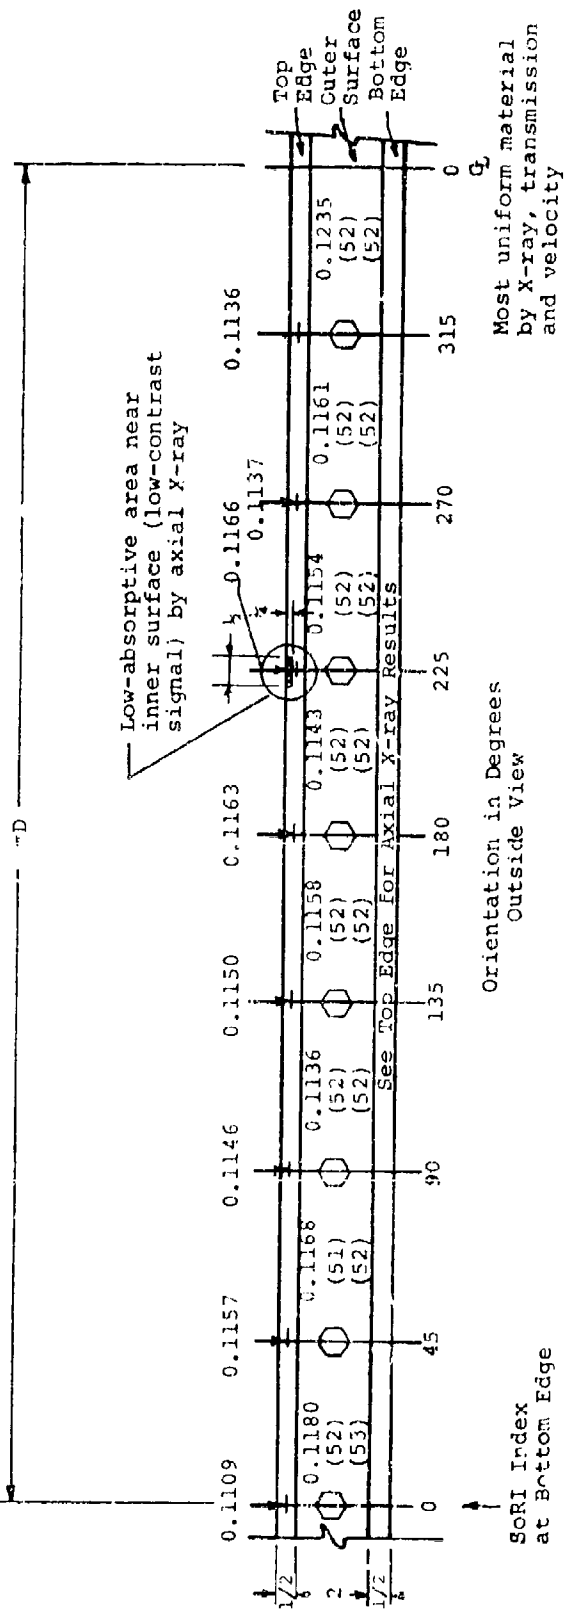
Figure 39. Sketch Showing Inspection Results on Ring 9P-2 from Sandia Felt CC

1.  $\odot$  Radial Velocity in in./ $\mu$ sec  
(Relative radial transmission in added-dB) - 1st Run } Higher transmission readings correlate lower attenuative material  
(Relative radial transmission in added-dB) - 2nd Run }
2.  $\dagger$  Axial velocity in in./ $\mu$ sec
3. Visual inspection results - no single flaws
4. Penetrant inspection on edges using 2, 2, 4-Trimethylpentane - no single flaws
